# Manhole Inspection Summary

Manhole # S39U1\_017MH

Insp Date: **12/3/07 1:34 PM**

**Location** Address: **420 Baltic Ave**

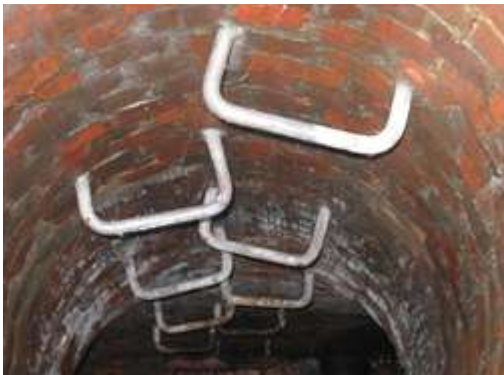
Steps

Count: **9** Missing: **0** ☐ Corroded

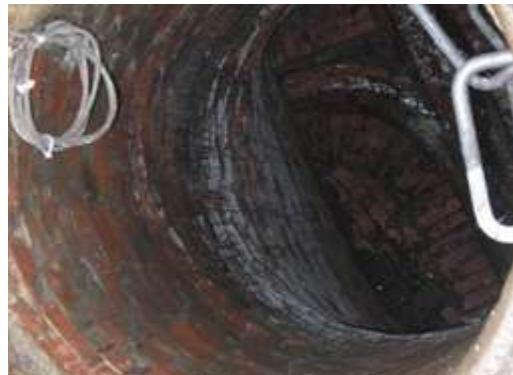
Defect 2

Infiltration: ☐ None ☐ Joint ☐ Cracks ☐ Mortar ☐ Roots ☒ **Wall**

Wall infiltration

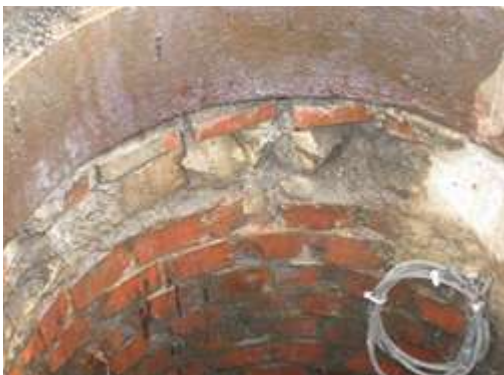
Defect 1

Condition: ☐ Sound ☐ Cracked ☐ Root Intrusion ☒ **Loose Brick** ☐ Deteriorated

Loose bricks

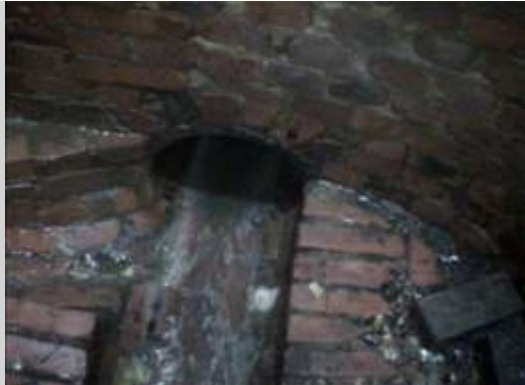
12 O'Clock Outflow

12 in. Circular Gravity Sewer  
Pipe Out @ 12 O'Clock

Pipe Height: **15.6** (in.) Rod and Bar (Angled)  
Pipe Material: **Clay** ☐ Pipe Lined  
Invert Depth: **16.30** (ft.) Flow Characteristics: **Fast**  
Deposits: ☒ None ☐ Mud ☐ Sludge ☐ Debris ☐ Grease  
Silt Depth: (in.) Deposits Extent:  
Infiltration: **None** Pipe Seal Cond: **Sound**

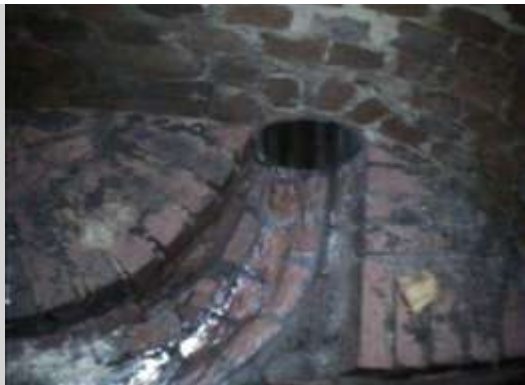
3 O'Clock Inflow

8 in. Circular Gravity Sewer  
Pipe In @ 5 O'Clock

Pipe Height: **9.6** (in.) Rod and Bar (Angled)  
Pipe Material: **Clay** ☐ Pipe Lined  
Invert Depth: **15.72** (ft.) Flow Characteristics: **Fast**  
Deposits: ☒ None ☐ Mud ☐ Sludge ☐ Debris ☐ Grease  
Silt Depth: (in.) Deposits Extent:  
Infiltration: **None** Pipe Seal Cond: **Sound**

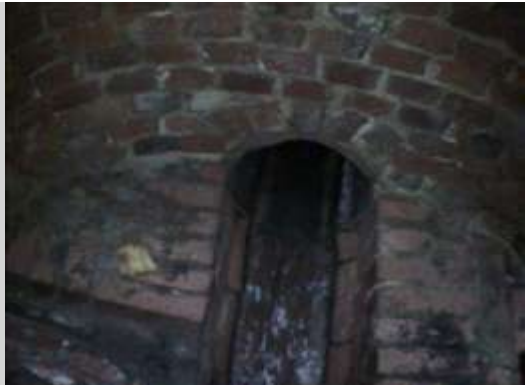
6 O'Clock Inflow

12 in. Circular Gravity Sewer

Pipe In @ 6 O'Clock

Pipe Height: **8.4** (in.) Rod and Bar (Angled)

Infiltration: **None** Pipe Seal Cond: **Sound**

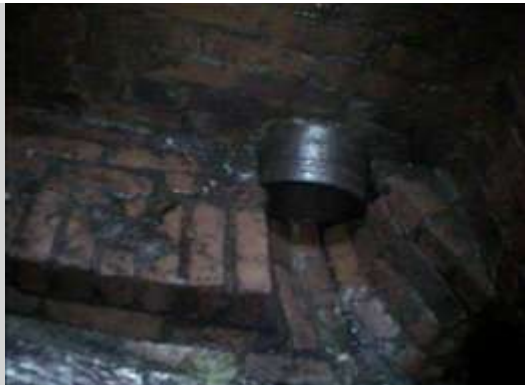
9 O'Clock Inflow

8 in. Circular Gravity Sewer

Pipe In @ 11 O'Clock

Pipe Height: **8.4** (in.) Rod and Bar (Angled)

Pipe Material: **DIP/CI** ☐ Pipe Lined

Infiltration: **None** Pipe Seal Cond: **Sound**
